# Assessing Compliance to Minimum Service Standards of Indonesian Toll Roads: An Examination of the Padaleunyi Toll Road

**Abstract:** The primary objective of this study encompasses the evaluation of the Padaleunyi Toll Road's service performance, particularly in relation to Indonesia's established minimum service standards for toll roads. Given that the Padaleunyi Toll Road currently stands at mid-life in terms of its service duration, it is crucial to undertake this assessment to predict its remaining useful life. Criteria for measuring minimum service standards' fulfillment were diversified to cover the conditions of the toll road, average vehicular speed, accessibility, mobility, safety parameters, availability of rescue units and service assistance, environmental impact, and features of rest and service areas. The employed research methodology was based on the guidelines provided by Regulation 16/PRT/M/2014 from the Indonesian Ministry of Public Works. Findings indicate a compliance level of 66.04% to the minimum service standards, with the poorest indicator being the condition of the toll roads at a mere 14%. This study hopes to contribute by offering comprehensive insights

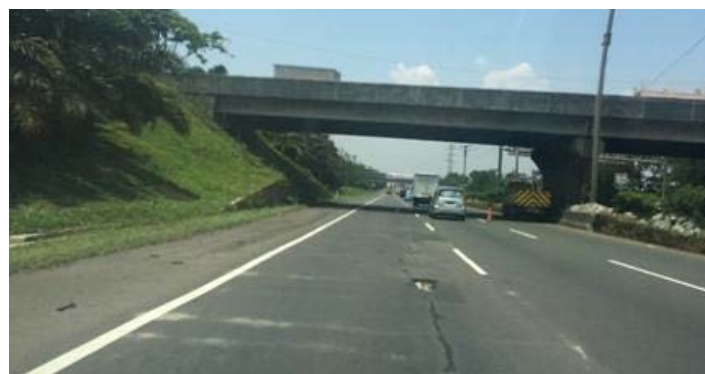
standards for toll road conditions reached a mere 14% of the expected level. Specifically, the only criteria that were met were the roughness and roughness of the main pavement. Conversely, the requirements of having no holes, rutting, and cracks on the main road pavement, as well as proper roadside conditions, were not fulfilled. Furthermore, improvements are needed in all drainage conditions. The median condition, encompassing the curb, median concrete barrier (MCB), guard rail, and wire rope, also fell short of meeting the standards. An example illustrating the presence of cracks and pothole damage on the main road and shoulder pavement is showcased in Figures 2-3.

The condition of the main line pavement exhibits variability, with some sections being overlaid and in excellent condition while others could benefit from further enhancement. The road surface has experienced significant wear and tear, despite the application of patches to many areas. Numerous cracks, grooves, longitudinal cracks, and holes are present, with longitudinal cracks being particularly common in the joint area between adjacent pavement layers. According to Wahidin [17], both newly built roads and newly restored roads (overlays) experience a decrease in structural function over time. Additionally, damage can occur due to the interaction of friction between vehicles and the road pavement, such as sudden braking at high speeds [17, 18]. Such damage weakens the asphalt pavement structure, leading to pavement deformation and the subsequent occurrence of pavement roughness. The presence of pavement roughness negatively impacts vehicle performance and traffic safety.

**Figure 2.** Longitudinal cracks and holes in the main line pavement at km 135

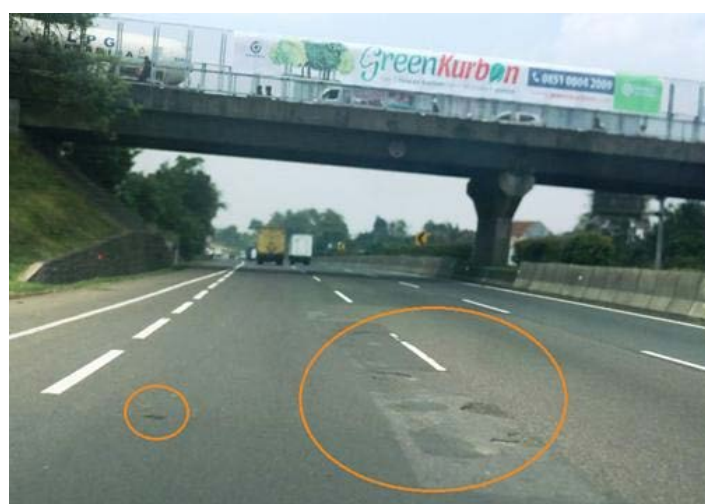
**Figure 3.** Damage at km 128

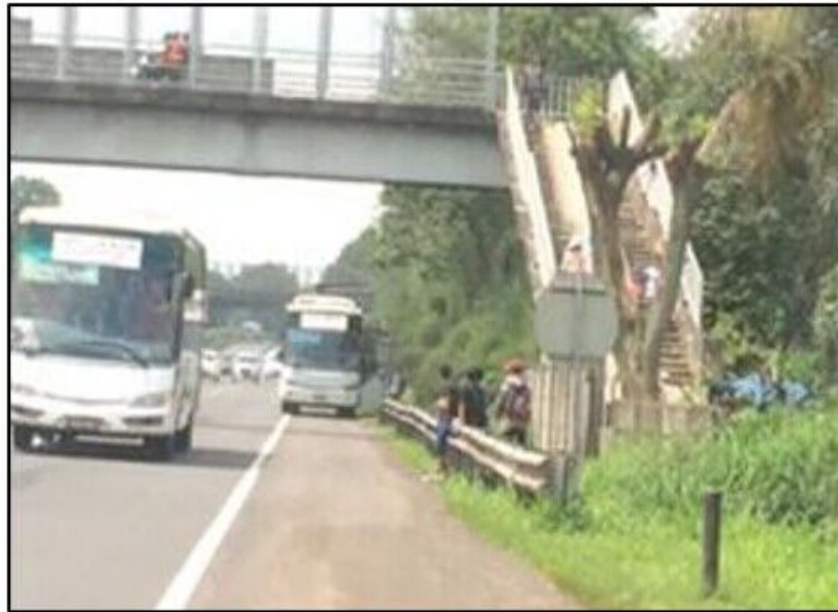
**Figure 4.** Absence of right-of-way fence
