# Performance Evaluation of a Four-Legged Signalized Intersection with Variable Traffic Flow Dynamics

Eren Dağlı<sup>1\*</sup>, Metin Mutlu Aydın<sup>2</sup>, Zeljko Stevic<sup>3</sup>

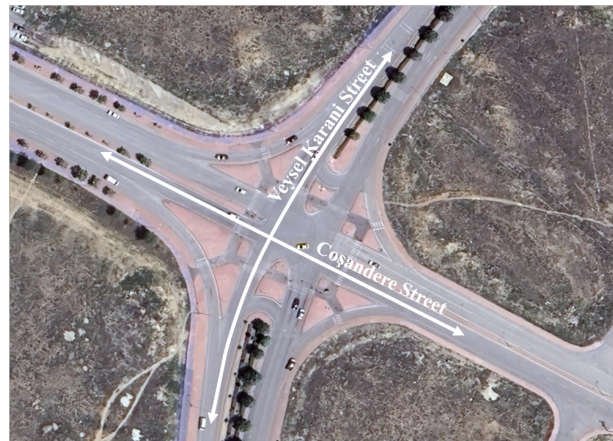
**Figure 2.** Coşandere intersection view

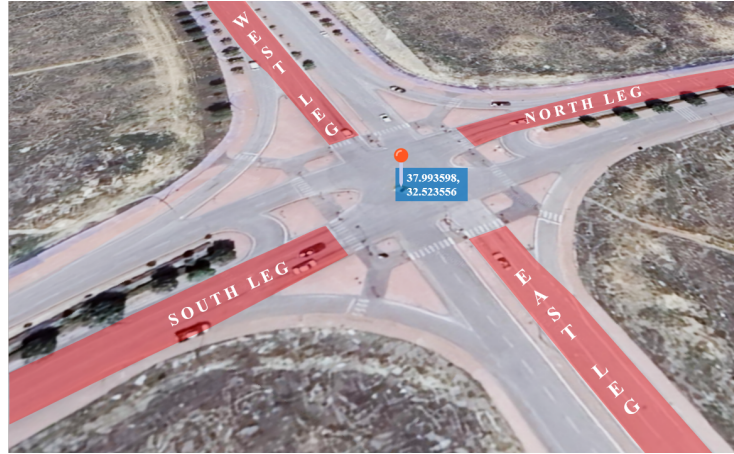
**Figure 3.** Intersection location and name of intersection legs

The Coşandere intersection is very close to Selçuk University, and the neighborhood has a dense settlement and mobility. The intersection is located at the junction of several intercity roads. This situation has an increasing impact on vehicle traffic. The Coşandere intersection is named based on the directions of the approach legs, as shown in Figure 3. The south and north approach legs have left turn lanes and are three lanes. The east and west approach legs have two lanes; on the west approach leg, one lane before the intersection is dedicated directly to the right turn pocket. Right-turn islands are also on all four legs, and U-turn pockets are on the south and north approach legs.

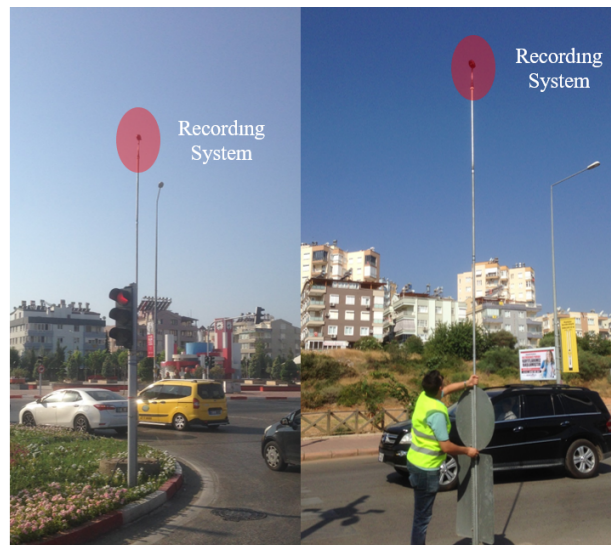
**Figure 4.** Used video recording system [22]

Field observations were conducted to obtain traffic data for the Coşandere intersection under study. During the field studies, it was observed that the traffic volume values for the Coşandere intersection do not vary much on different days. The evening volume is higher than the morning peak volume and is worthy of investigation. During midday, the number of vehicles is deficient compared to the evening or morning peak hours. One of the main problems encountered in the data collection phase of traffic engineering field studies is the complete determination of the movement of all vehicles in the study area. A video filming device (Figure 4) was used that allows wide-angle shots from a high point [22].
